Technical Report CERC-95-19 December 1995

# Periodic Inspection of Jetties at Manasquan Inlet, New Jersey

Report 1 Armor Unit Monitoring for Period 1984-1994

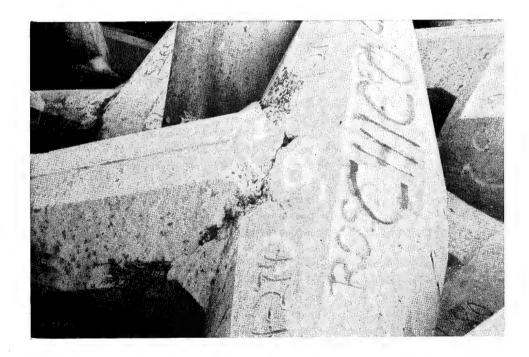
Figure 20. Dolos on south jetty with shank-fluke crack

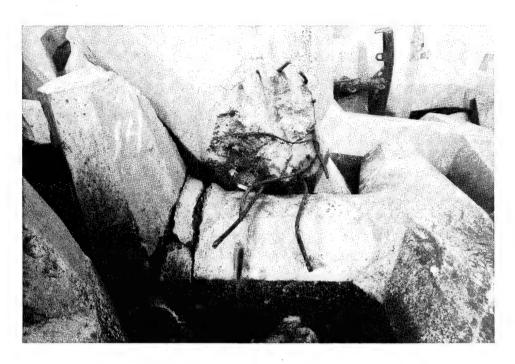
Figure 21. Dolosse on north jetty with shank-fluke breaks

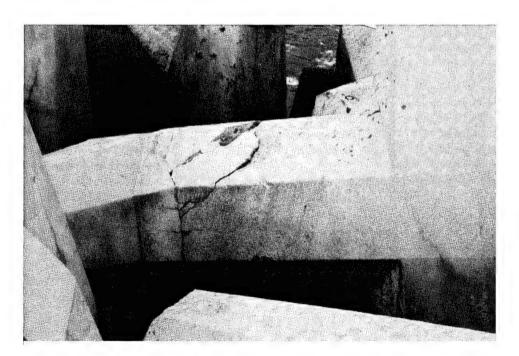
Figure 22. Dolos on north jetty with mid-shank crack

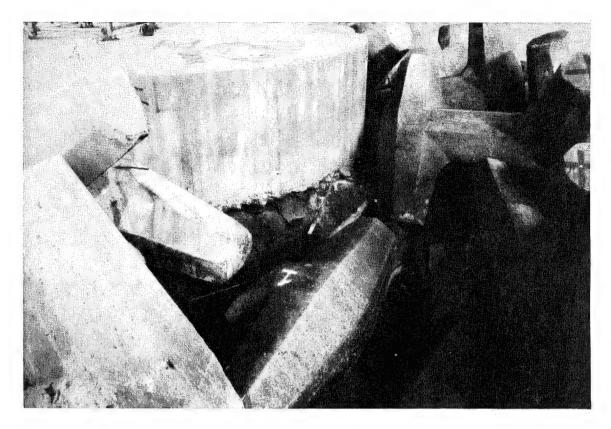
Figure 25. Core stone exposed at head of south jetty due to broken armor units

The current broken armor unit survey revealed 17 broken/cracked dolosse as opposed to 5 in 1984. The only area of concern was at the head of the south jetty where a broken unit resulted in exposure of core stone under the jetty cap. A temporary repair was subsequently performed by the Philadelphia District.
